## 2015年4月ネパール地震 (Gorkha地震) における 建物被害に関する情報収集調査速報

### Flash Report on the Damage of Masonry Housing Caused by Earthquake in the case of Gorkha Earthquake, 25 April 2015

## Flash Report on the Damage of Masonry Housing Caused by Earthquake in the case of Gorkha Earthquake, 25 April 2015

Tsuneo OHSUMI\*, Hiroshi IMAI\*, and Hiroshi INOUE\*

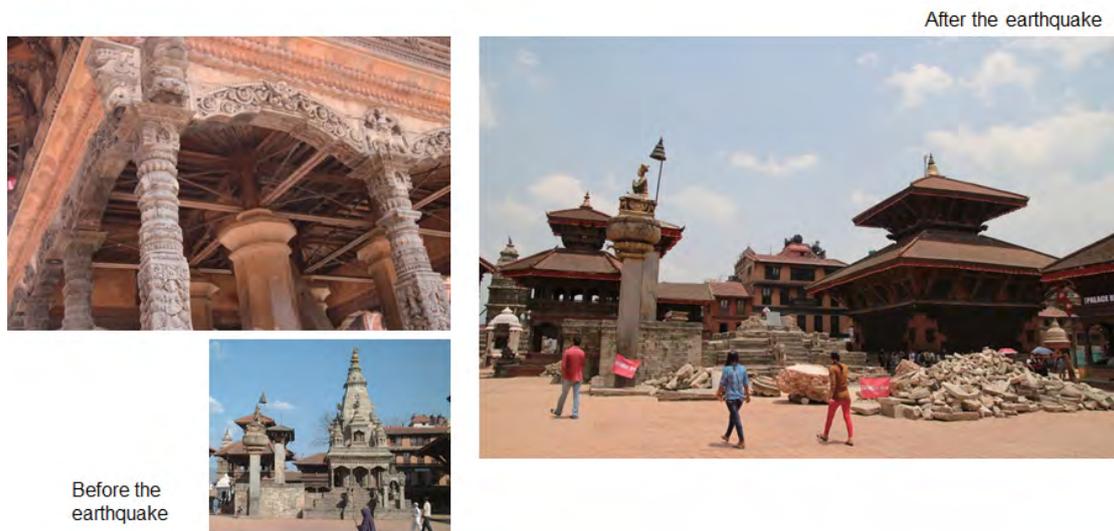
Many of Sikhara in Bhaktapur’s Durbar Square were severely damaged. The steel frame reinforced Chayslin duga temple (left) (**Fig. 3.2**). This temple was no damaged. During the 1934 earthquake Chyasilin Mandap was completely destroyed. Architects Götz Hagemüller and Niels Gutschow set about rebuilding this temple due to the metal reinforcements by GTZ fund. The Vatsala temple (center), which is Newar style temple, ca.1690, was destroyed. Yaksheshvara temple (right) survived.

**Fig. 3.2** Reinforced Chayslin duga temple (left) by steel frame, Vatsala temple (center) was destroyed and Yaksheshvara temple (right) survived (Photo. by T. Ohsumi).

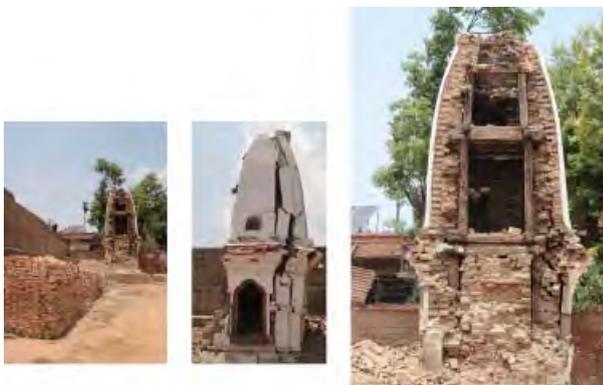
This structure materials are polished decorative bricks of high quality terracotta for lintels of doors and for decorative layers are integrated into the facades (**Fig. 3.3**). Inside materials are unburned bricks and timber frames. This sikhara had to be demolished later.

**Fig. 3.3** This sikhara was demolished (Photo. by T. Ohsumi).

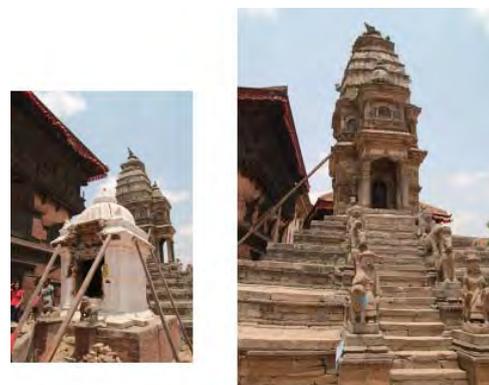
Chasin Mandapa (left) was broken in the lintel (**Fig. 3.4**). Siddhilakshmi Shikhara (right) survived, except the top of finial. This temple’s construction used stone and Indian style. This style developed in India during the late 6th century, it only appeared in Nepal during the late Licchavi period, 9th century. There was no damage to the statues of guarding lions and the steps leading to the main entrance. The Fasi Dega

**Fig. 3.4** Chasin Mandapa (left) and Siddhilakshmi Shikhara (right) (Photo. by T. Ohsumi).

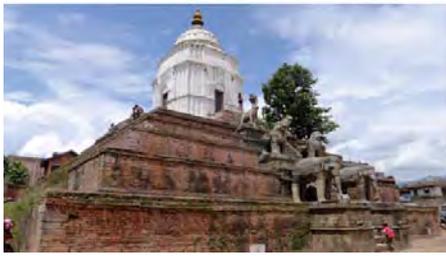
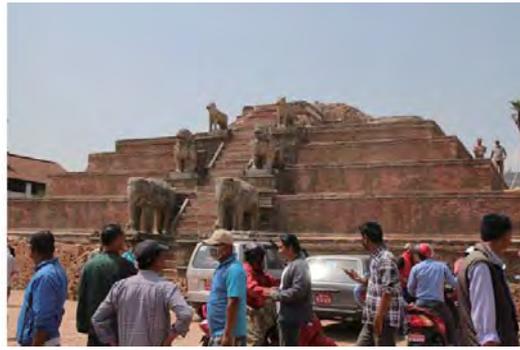
was destroyed (**Fig. 3.5**). The large, white Fasi Dega Temple was dedicated to Shiva and it was one of the tallest temples in the second part of Bhaktapur Durbar Square.

**Fig. 3.5** The Fasi Dega was destroyed (Photo. by T. Ohsumi).

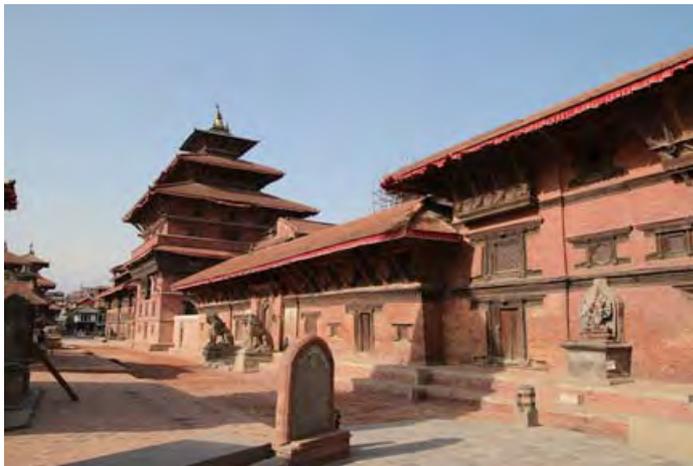
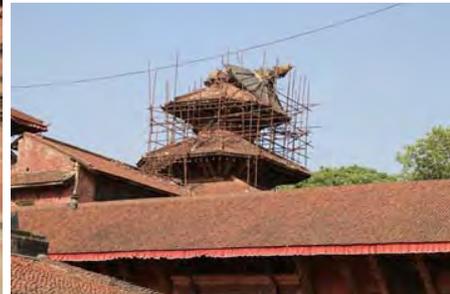
Thus, in Patan, 2015, after the earthquake, this place had only partial damage at Gajur and Baymvah (Fig. 3.9-10).

**Fig. 3.9** Patan 2015, after the earthquake, this place had partial damage at Gajur and Baymvah (right) (Photo. by T. Ohsumi).

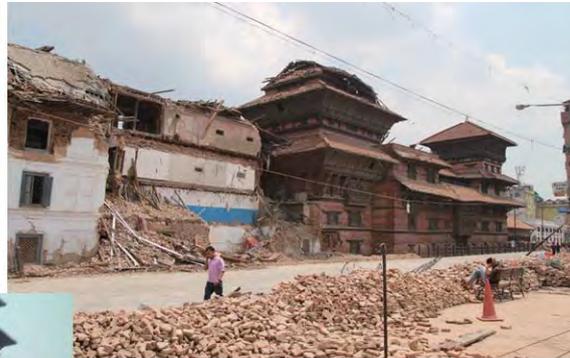
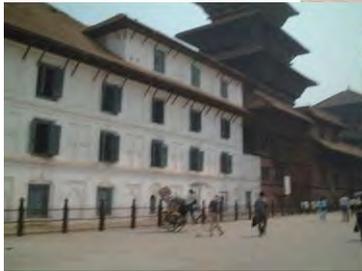
The old palace structures in Kathmandu’s Durbar Square, which had no renovation, had severe damage (Fig. 3.12). On the left side of the white structure, which was Lana Dynasty 150 years ago. On the right side of a four-tiered brown temple, which was Gorkha Dynasty 300 years ago.

Fig. 3.12 Kathmandu Durbar Square after the earthquake (right), before earthquake (left) (Photo. by T. Ohsumi).

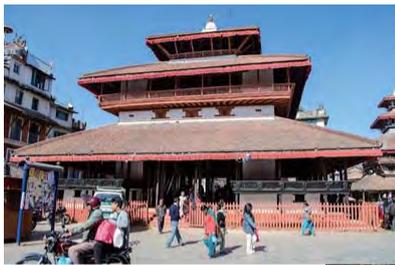
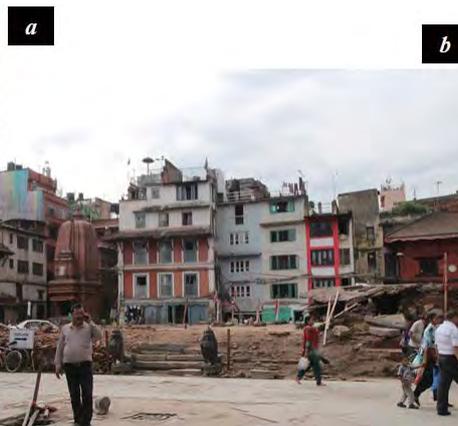
Narsingha Malla in the early 16th century. The whole temple was made from a single tree (Fig. 3.13). Kasthamandap is said to be the etymology of Kthmandu. The earthquake on April 25, 2015 caused severe damage to this temple and it collapsed.

Fig. 3.13 Kasthamandap temple before the earthquake (a) / after the earthquake (b) (Photo. by T. Ohsumi).

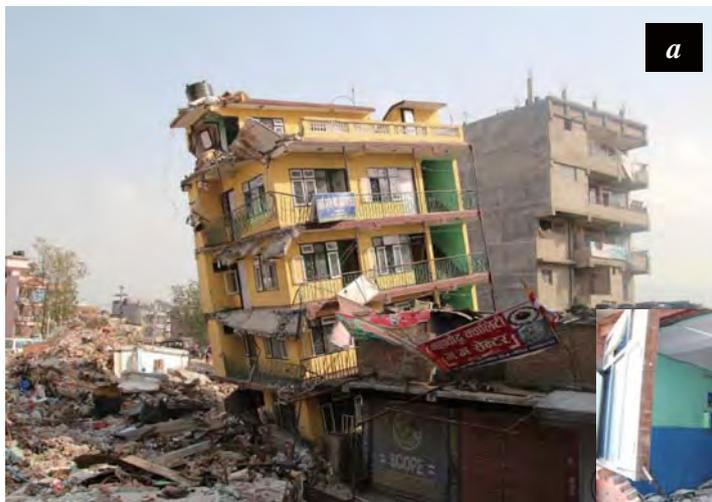
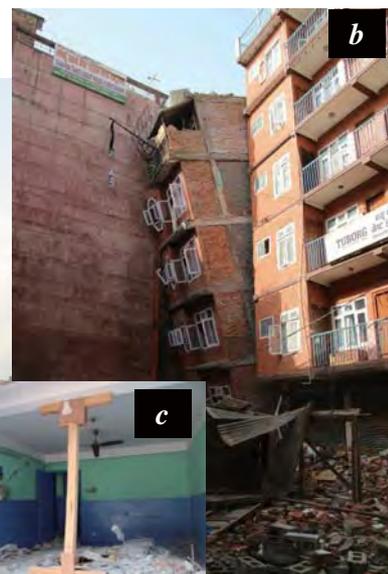
and at Sitapatla, southwest of Ring Road, the building damage was caused by the soft ground area on the river branch (Fig. 3.14). At west side of the Ring Road in Kathmandu, RC frame buildings were tilted (Fig. 3.15). At

Fig. 3.14 At Gongabu, RC frame buildings were tilted (a,b). A shear crack in the first floor (c) (Photo. by T. Ohsumi).

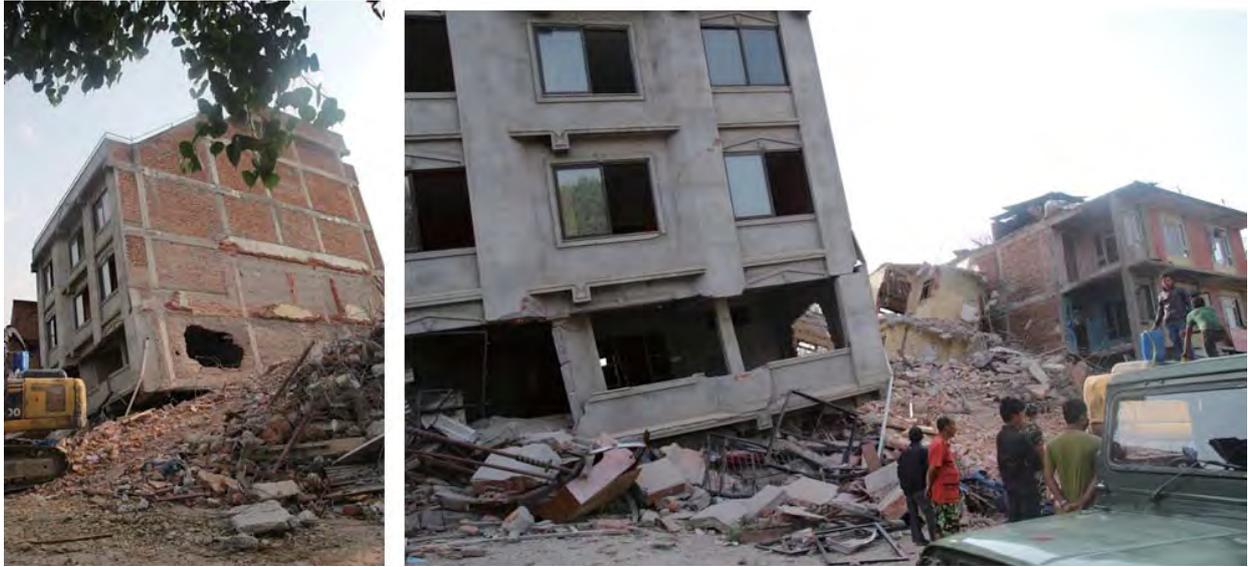
Fig. 3.15 At west side of the Ring Road in Kathmandu, RC frame buildings were tilted (Photo. by T. Ohsumi).

- 1) Westside of the Ring Road in Kathmandu, RC frame buildings were tilted. The building damage was caused by the soft ground area on the river branch.

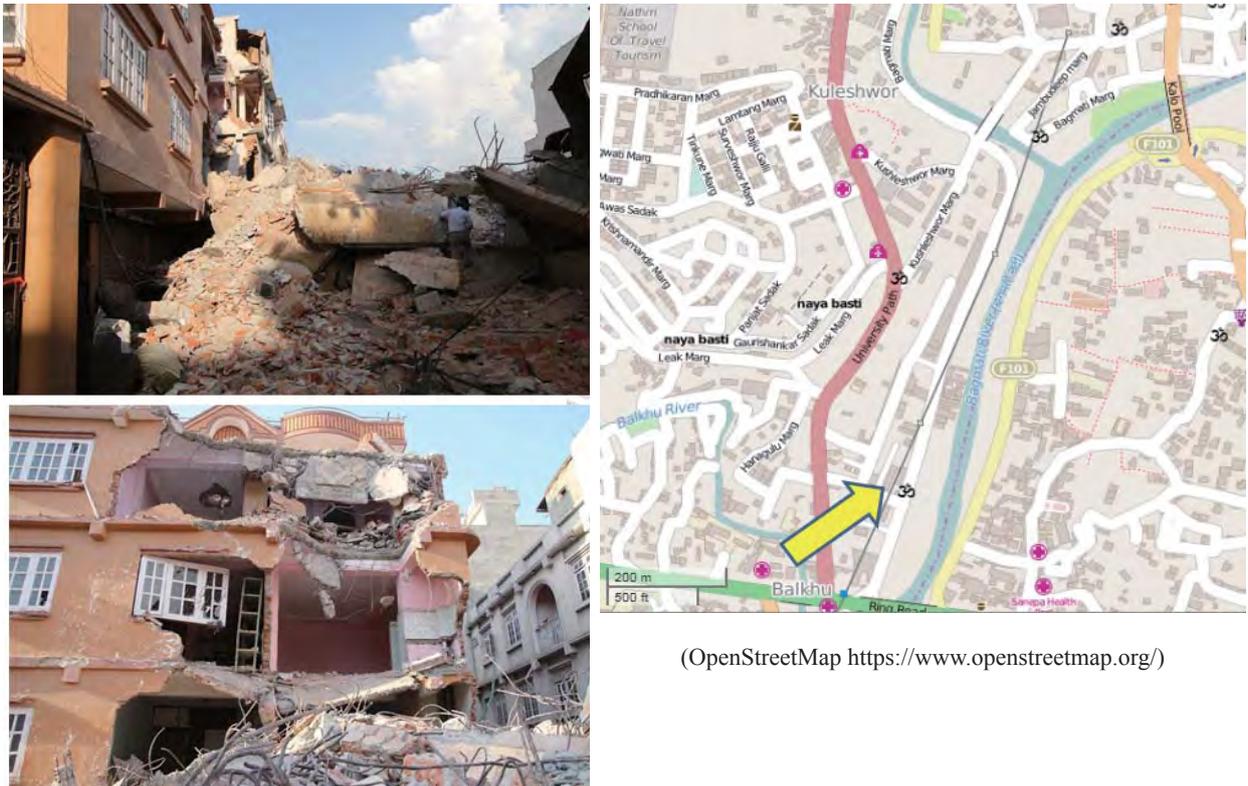
the branch point of the Bagmati River and the Transformor River, collapsed buildings fell onto and destroyed the next building (Fig. 3.16).

Fig. 3.16 At the branch point of the Bagmati River and the Transformer River, collapsed building fell onto and destroyed the next building (Photo. by T. Ohsumi).

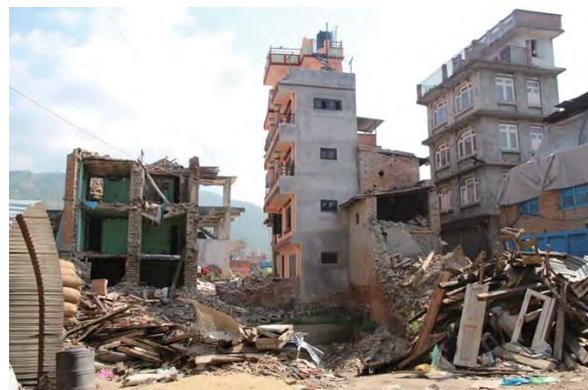
Fig. 3.19 RC buildings were partially damaged, the difference appears remarkable in Sankhu (Photo. by T. Ohsumi).

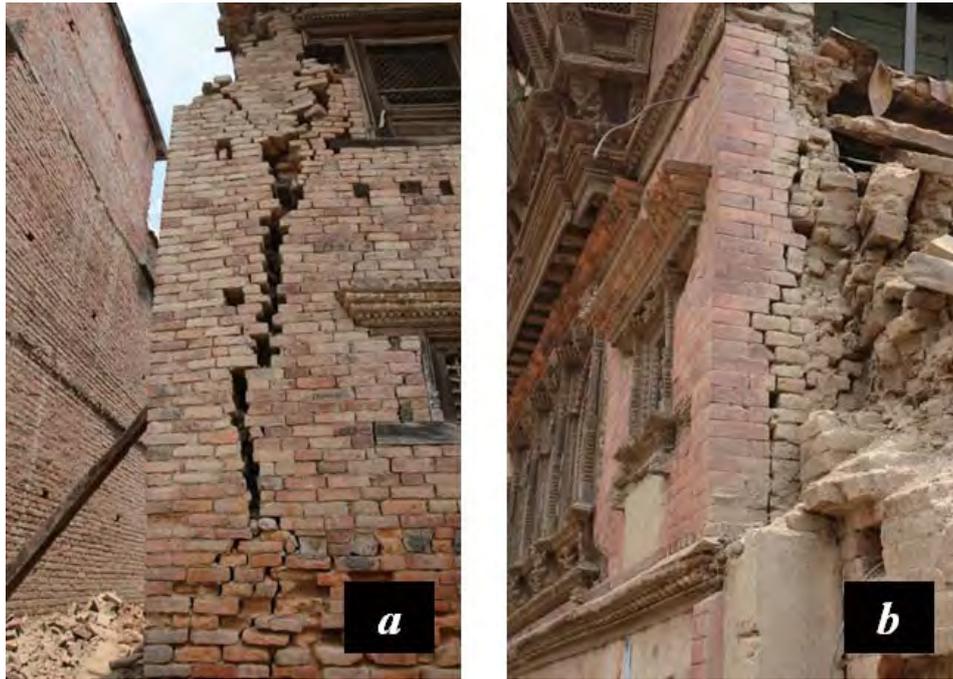
**Fig. 3.20** A vertical crack in a brick masonry wall was generated from the corner (a). Structures having no RC columns on the corner (b) (Photo. by T. Ohsumi).

- 2) RC buildings were partially damaged the difference appears remarkable. The brick and cement mortar houses without RC columns had a lot of damage. Structures having no RC columns on the corner, a vertical crack in a brick masonry wall was generated.

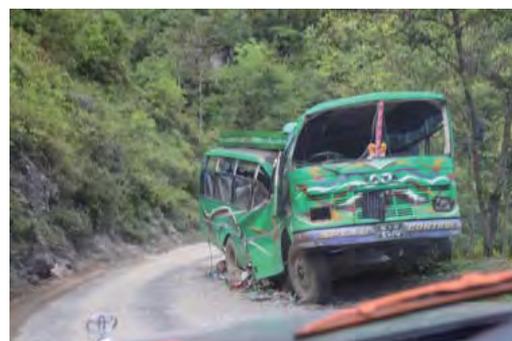
**Fig. 4.1** Bus was hit in falling rocks in Dhikure, on Baglung Rajmara High way (Photo. by T. Ohsumi).

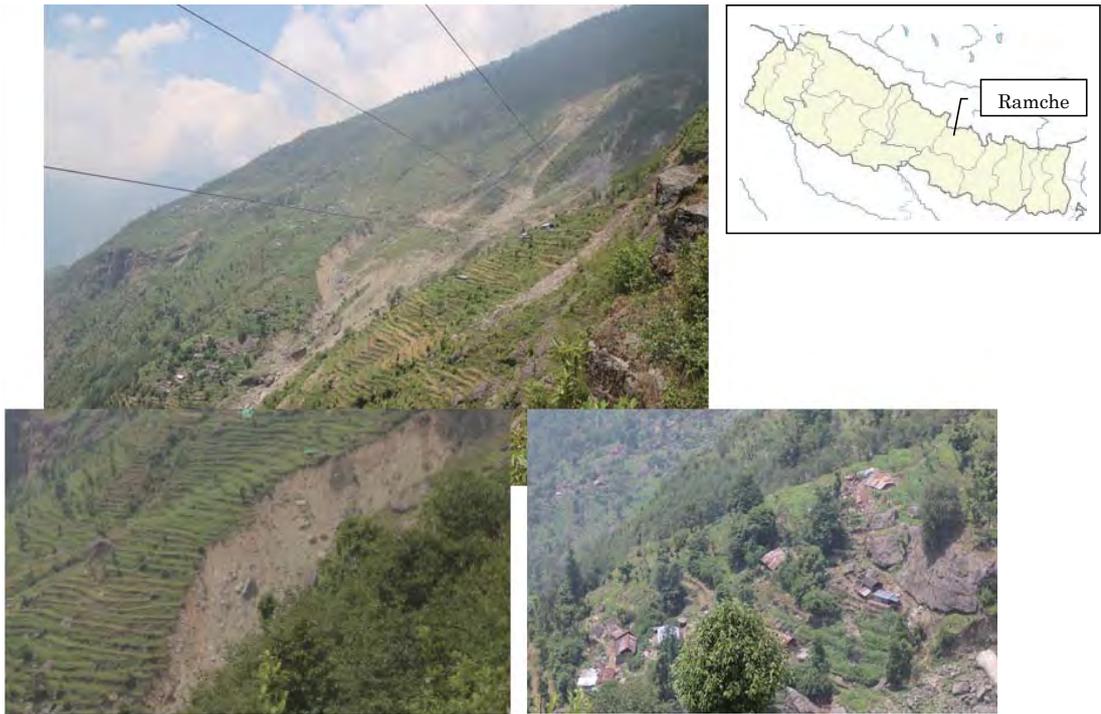
A numerous number of huge slope failures which occurred in the mountainous area buried villages and valleys, and resulted in the loss of many lives. We visited a landslide zone in Ramche, and it is located in the northwest of Kathmandu city in a mountainous area. Many of fallen rocks were on the roads, also we encountered a bus that hit by falling rocks (Fig. 4.1). Thick talus is deposited in the landslide area in Ramche, in Rasuwa district (Fig. 4.2). The town is located at an altitude of 2,068 m. There are houses that had been caught in a landslide, but the damage was limited. However, the whole scope of the slope failures is not clear at the present time, because any detailed and total survey in the mountainous area has not been carried out. Thus, causalities will increase as they are found.

**Fig. 4.2** Thick talus is deposited in the landslide area in Ramche (Photo. by T. Ohsumi).

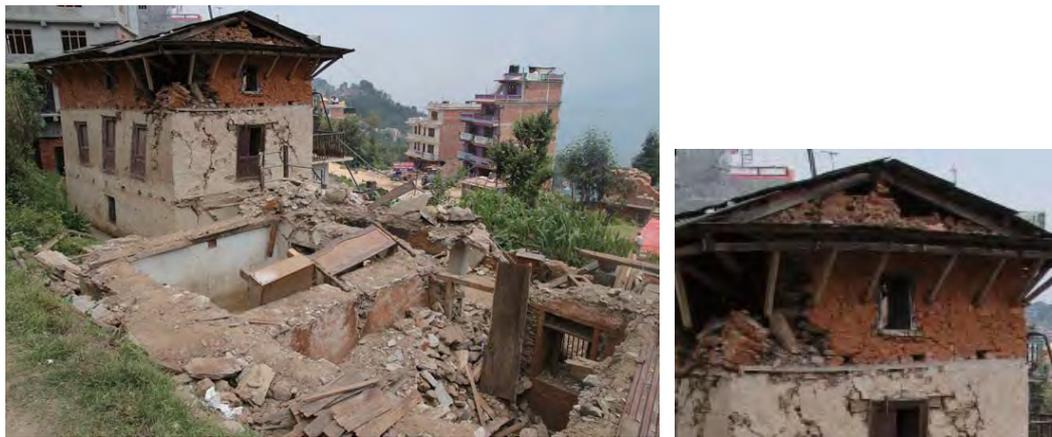
In Dolakha district, adobe style houses collapsed. First, this adobe houses collapsed at the gable and cracked at corner by ground motion. Many adobe style houses broken at gable (Fig. 4.3). Stone style houses also collapsed by delamination.

**Fig. 4.3** Adobe style houses collapsed at the gable part in Charikot, Bhimeshwor Municipality (Photo. by T. Ohsumi).

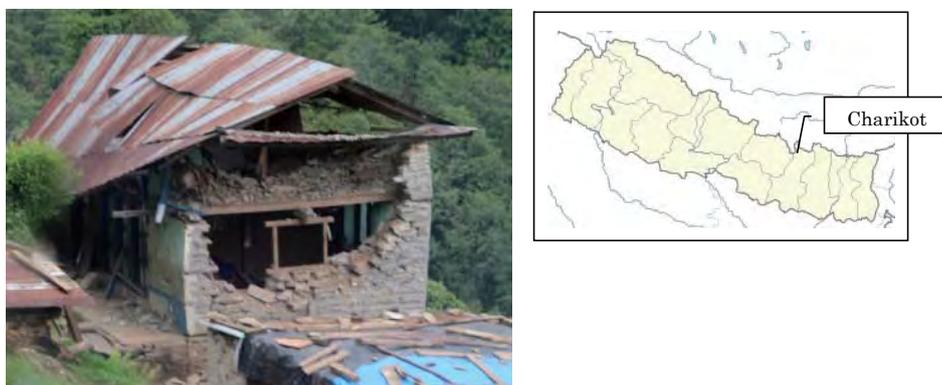
Stone style houses also collapsed by delamination. Stone style housing used a shaped schist as stone masonry material. Typical case of stone construction the masonry used was a mud mortar in the joints. The wall thickness was more than 50 cm. Many 2-3-story housing the floor is half-timbered. CGI sheet (galvanized wave plate) is used for roofing in half-timbered housing (Fig. 4.4).

**Fig. 4.4** Stone style house in Charikot, Bhimeshwor Municipality (Photo. by T. Ohsumi).

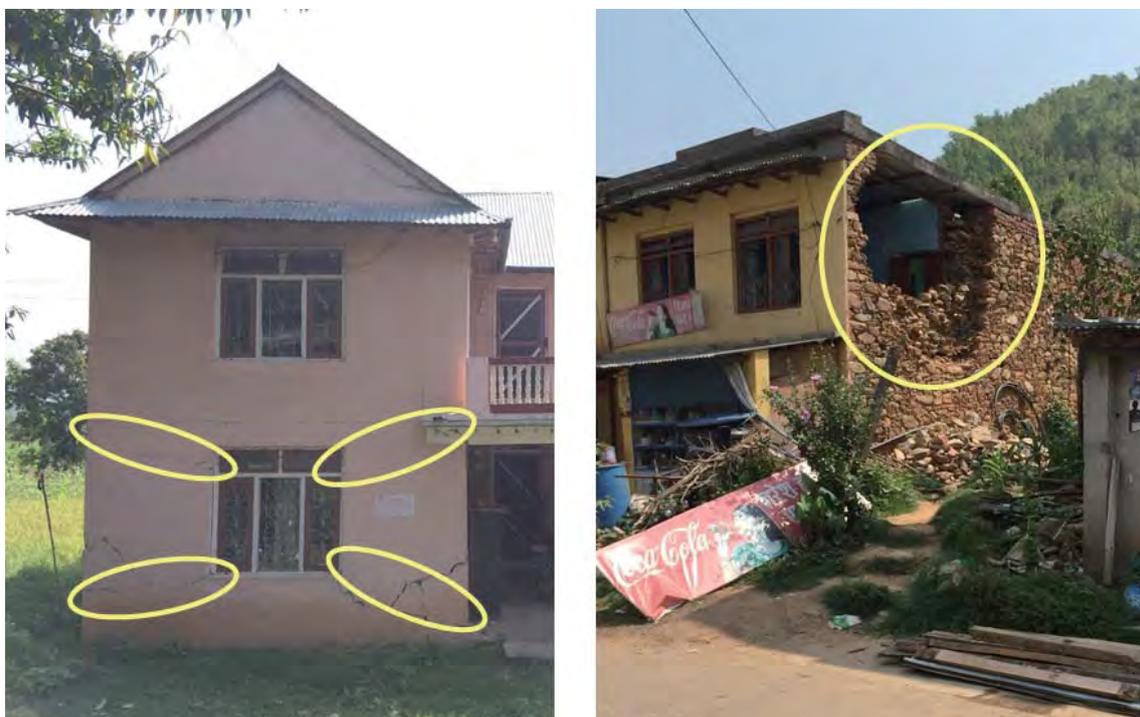
A mud mortar, which is especially low adhesive strength, adhesion between the material of housing is reduce during earthquake duration time. A brittle material or structure fractures or suddenly breaks while subjected to bending, swaying, and deforming. The mud mortar avoids the brittle structure due to the little tendency to deform before it fractures.

A typical low-story part of earthquake damaged housing causes shear failure of masonry wall. Typical failure pattern of non-engineered housings are out of plane by poor bonding strength.

Fig. 5.2 Typical failure pattern of Non-engineered housings left: Nuwakot, right: Ksthmandu (Photo. by H. Imai).
