## **Landslide Risk Evaluation and Mapping**

### **- Manual of Aerial Photo Interpretation for Landslide Topography and Risk Management -**

Toyohiko MIYAGI<sup>\*1</sup>, Gyawali B. PRASAD<sup>\*2</sup>, Charlchai TANAVUD<sup>\*3</sup>,  
Aniruth POTICHAN<sup>\*4</sup>, and Eisaku HAMASAKI<sup>\*5</sup>

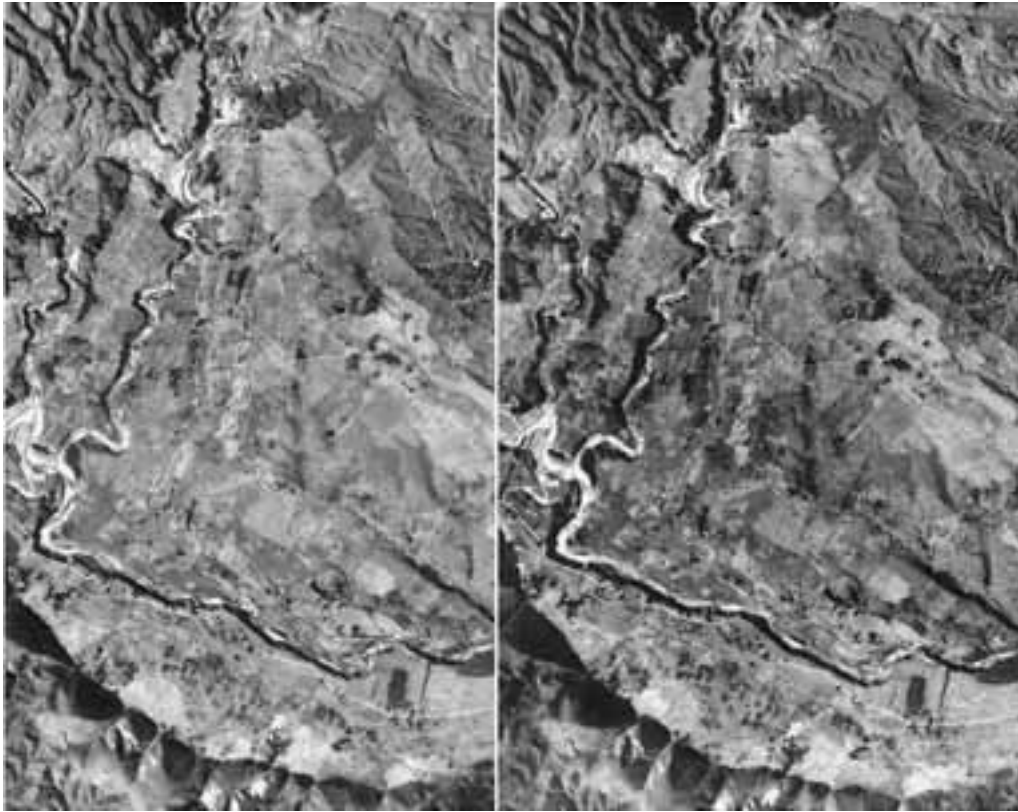
**Fig. 2.2** Stereo pair aerial photographs at the same place of small landslide topography and small altitude terrace cliff is relatively easy to identify.

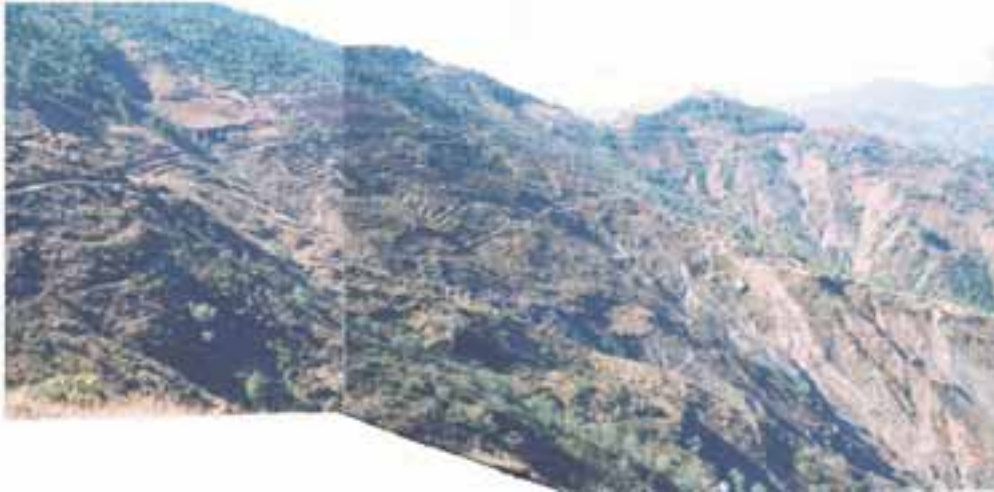
**Fig. 3.2** A view of Chisapani landslide at the uppermost Agrakhola watershed in the Central Middle Mountain range of Nepal. This is a very old landslide which reactivated in 1993 disaster and is still in active condition. Several cracks are developing on the head of the landslide, several active gullies are developing in landslide body and the new scarps are extending upward collapsing the unstable blocks of landslide (Photo view is from east to west).

**Fig.3.2** and **Fig.3.3** shows the Chisapani landslide which is located in the uppermost watershed of the Agra khola in the Makwanpur district of Nepal is the example of the old landslide in the middle mountain which reactivated in July 1993. This landslide killed 4 people and damaged 32 houses in the Chisapani village and debris flow and flood damaged the Prithivi high way at downstream. Although some people have already migrated from the landslide areas to other safe places like Hetauda and Terai, however most of the people are still living on the vulnerable area of the landslide. According to the version of local people in the landslide area, this landslide reactivated in 1993, 1954, 1970

and 1993. However no any recorded evidences has been found of reactivation of landslide in the past. Several old and recent scarps and linear tension cracks are clearly defined in the head and the landslide body which indicates that these landslides are still in active condition. All the agriculture lands (Bari and Khet) in the landslide area have been still using which is very high risk for the future reactivation.

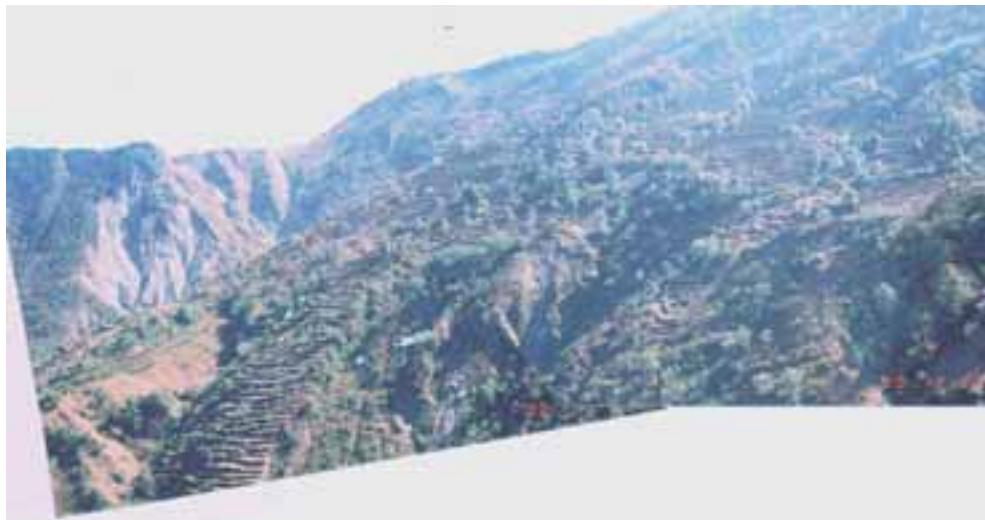
**Fig. 3.3** A view of Chisapani landslide at the uppermost Agrakhola watershed in the Central Middle Mountain range of Nepal. This landslide is very old and is still in active condition. (Photo view is from west to east).

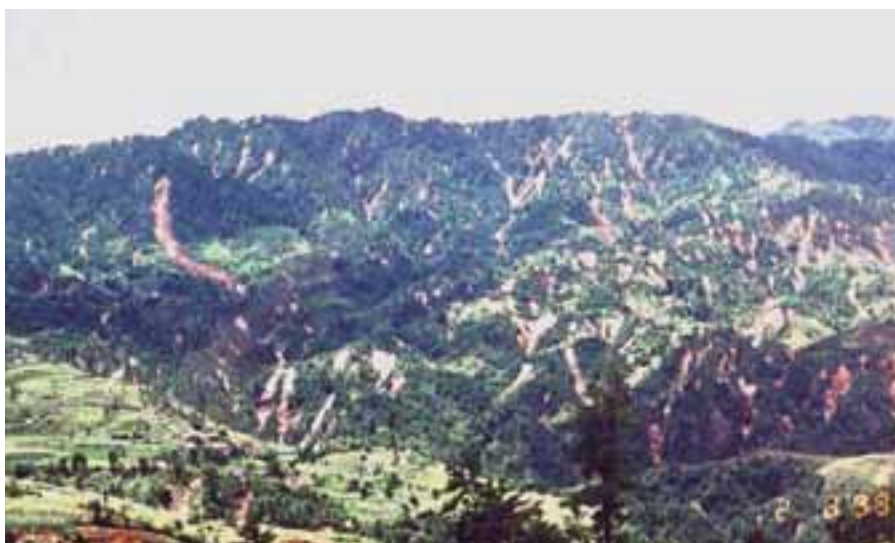
**Fig. 3.4** A view of surface landslide on the degraded Hillslopes at the uppermost of Kulekhani watershed in Central Middle Mountain of Nepal.

Several slope failures on the northern slope of the middle mountain which is located in the Palung village development committee, uppermost Kulekhani watershed Makawanpur district Nepal occurred due to heavy rainfall in July 1993 (**Fig.3.4**). The rainfall was recorded 540mm in 24 hrs in 20 July 1993. Similarly Namtar Bajar at the foothill upstream of the Manohari khola in Makwanpur District was washed way by accumulated debris flow and flood of Dhungakate khola and Ghatte khola. Several landslide, rockslide and gullies occurred in the upstream catchments area of Dhungakate khola and Ghatte khola due to same high rainfall intensity. The **Fig.3.5** shows Namtar Bazaar before and an after disaster. Tribhuban and Prithivi highways which are linkage road to Kathmandu, the capital of Nepal were damaged by several landslides. **Fig.3.6** shows the Jogimara landslide in the Prithivi highway. In addition, the foot trails in the middle mountainous regions also created big problems of water induced disaster in Nepal as shown in **Fig.3.7**. The foot trails are converted into gullies by the erosion due to runoff water and in which accumulated run off water scoured made deep gullies during the rainy season and concentrated of runoff initiated to trigger the landslide at the lower convex breaks of the Hill slopes.

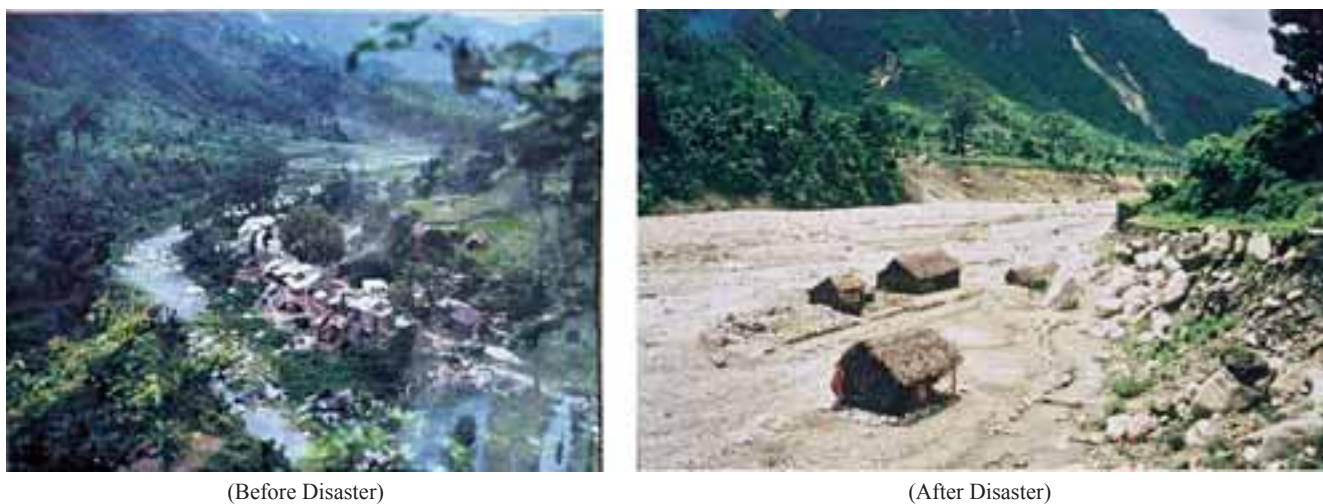
**Fig. 3.5** A view of Namtar Bazar (left) before and (right) after the disaster in July 1993 at the upper watershed of the Monohari River at the range of Middle Mountain and Siwalik Hills of Nepal.

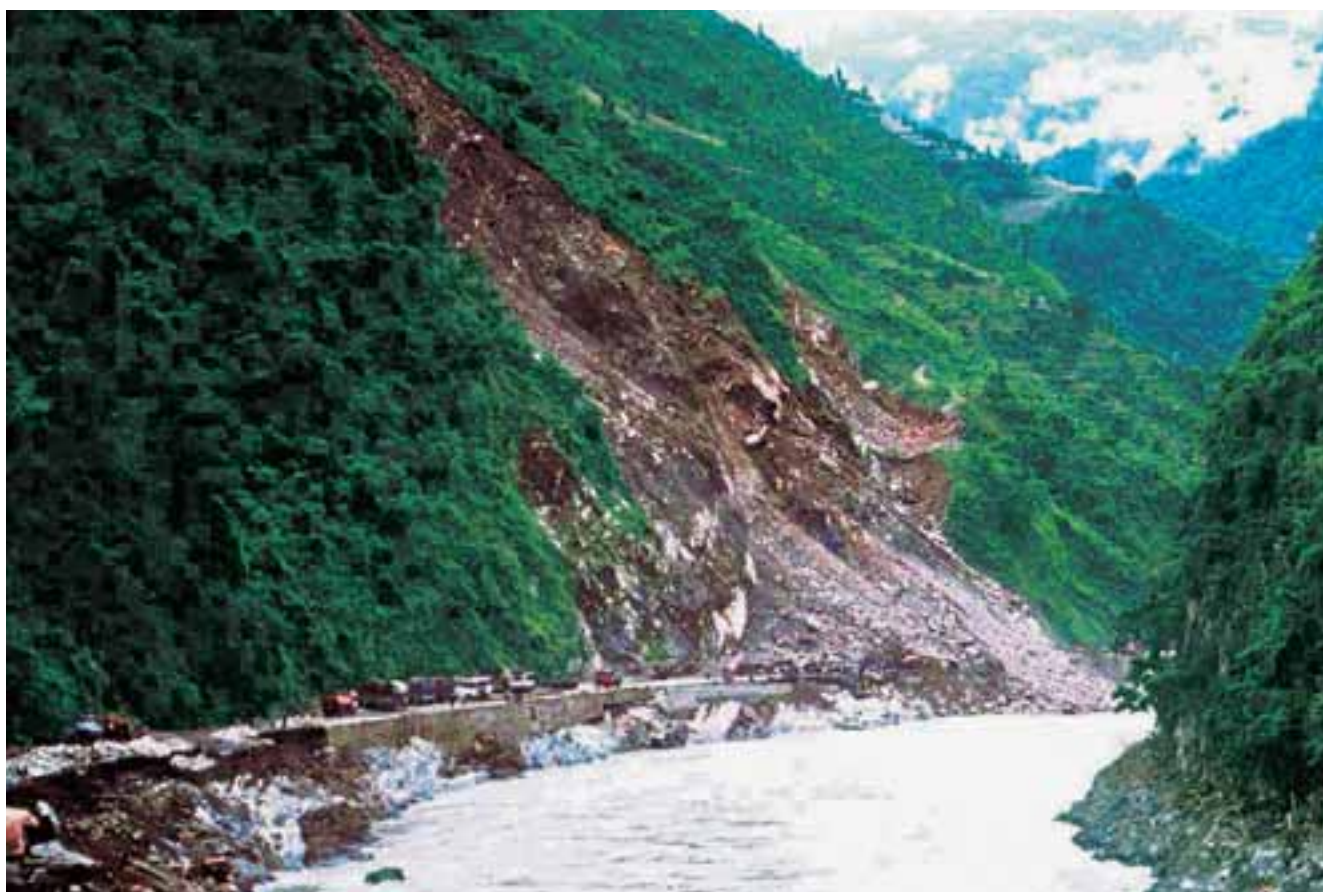
**Fig. 3.6** An over view of Jogimara landslide which damaged the Prithivi Highway (Muglin to Kathmandu road) in the Middle Mountain of Nepal. This photo was taken just after disaster in July 1993.

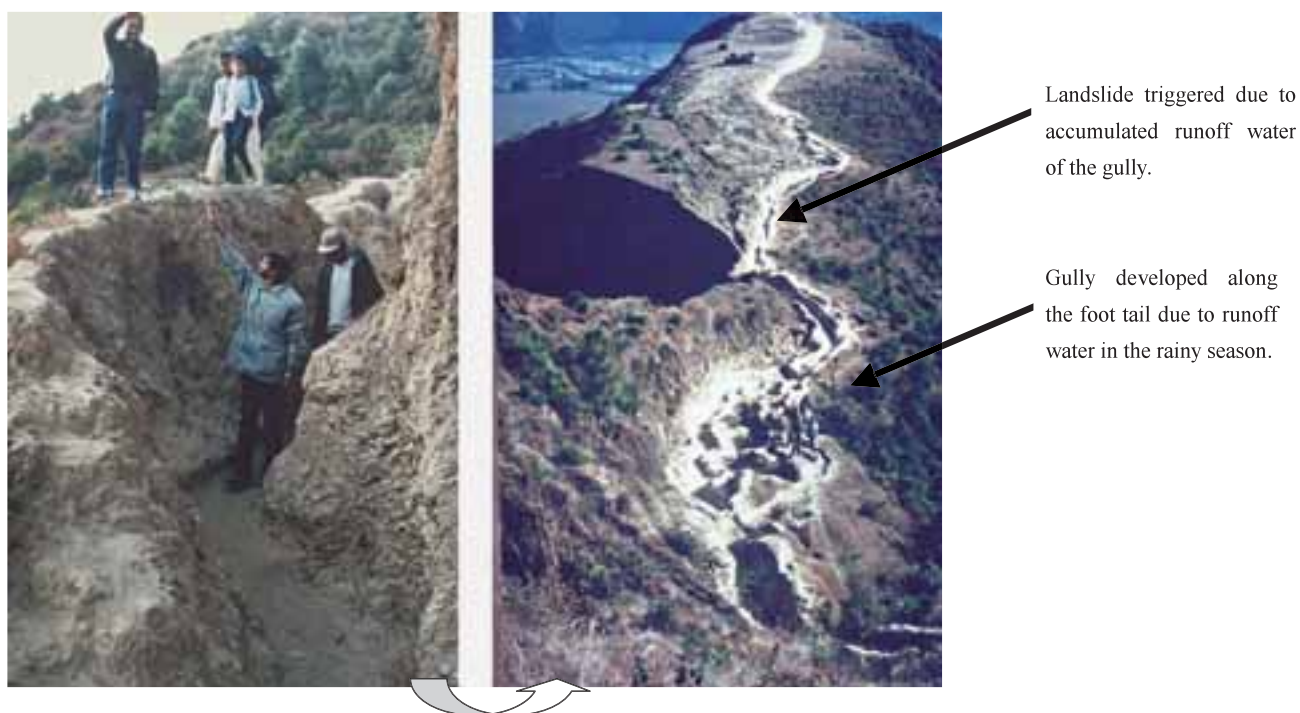
**Fig. 3.7** A view of foot trail at the Middle Mountain of Nepal, this foot trail changed to a gully and at the end the gully changed to a landslide due to accumulate surface runoff during the monsoon.

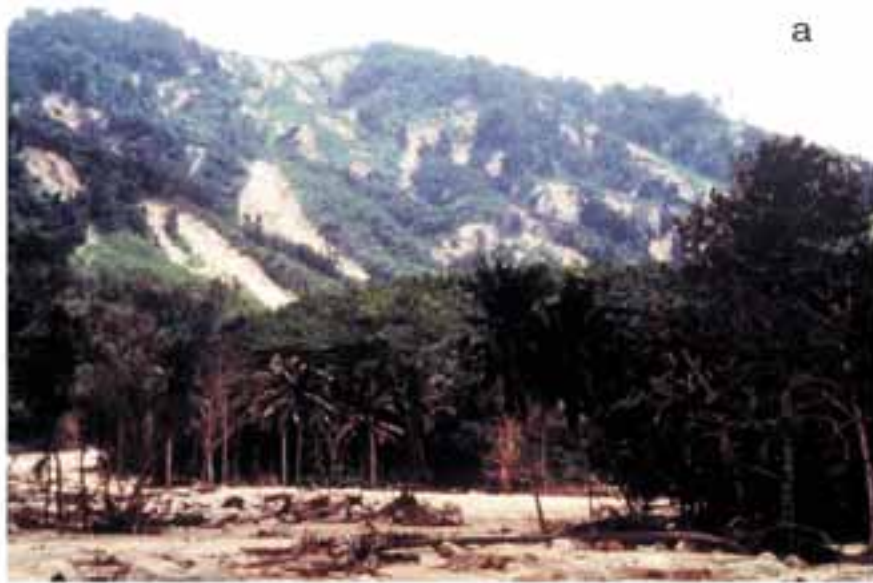
**Fig. 3.9** Landslide disaster at Phipun basin on the western hilly part of Nhkorn Si Thammarat province Thailand. a; an overview of surface landslides and debris. b; flood and sediment buried a village. c; slopping area is covered by rubber plantation. The rubber trees can not grasp the soil because of the shallow root system.

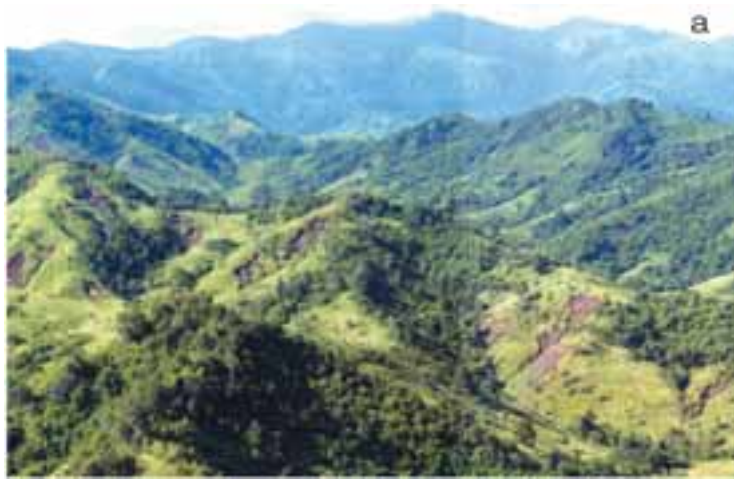
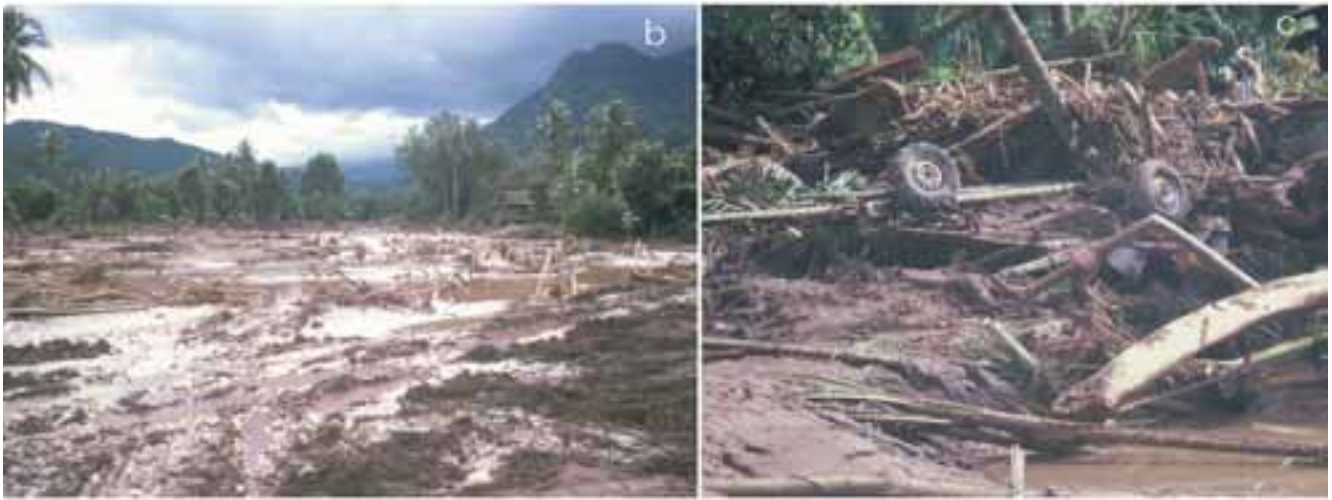
**Fig. 3.10** Landslide hazard hit two small villages where located by the river at the mountain margin of Lomsak basin, central Thailand. a; A great number of erosion landslides (scars) occurred at the poor land cover watershed. b; Flash flood washed away houses and lives. c; The debris only consist of fine materials and logs.

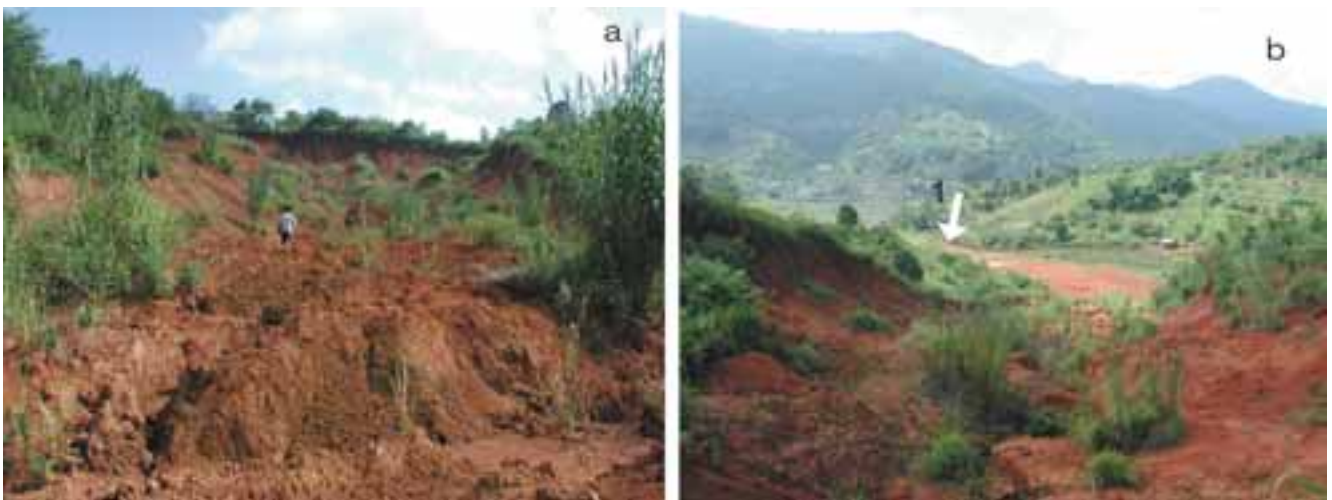
**Fig. 3.11** Rapid flow type landslide at the foot slope near Chiangmai City northern Thailand. a; The source area is located at the gentle hill foot slope which consist of deeply weathered andesite. b; The slip surface has gentle gradient and the body run and scattered long distance (white arrow is the portion of toe).

Rapid flow type landslide occurred at hill slope near Chiang Mai. The landslide destroyed a gentle hill slope which consists of deeply weathered andesitic rocks. The square of destroyed area reaches about 50m by 100m in the area and main scarp is 10 meters high. The landslide body was quickly transported to the river floor in lower reaches. This material transported about 300meters and thinly deposited, it established a wide flat plain. The trigger of the rapid flow type landslide seems to be the large amount of water infiltrate to the weathering body.

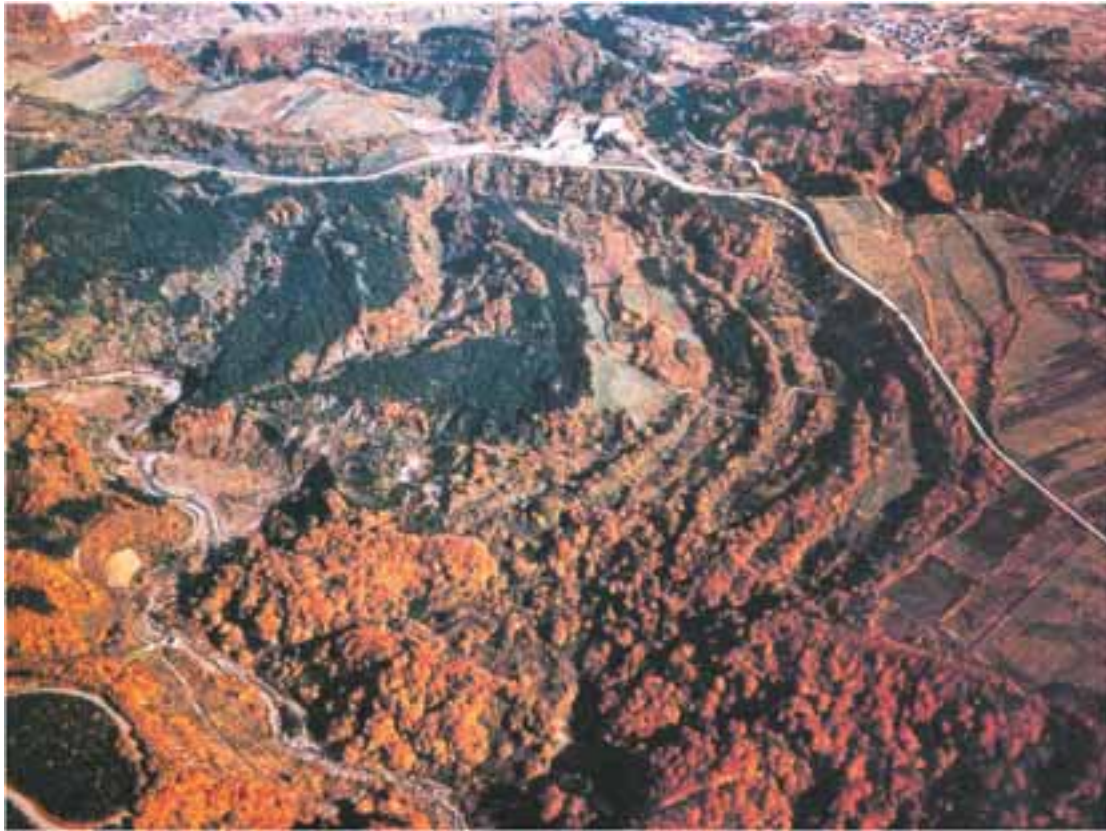
**Fig. 3.13** An overview of Sabuta landslide area Yamagata Prefecture eastern part of Dewa Mountains northeast Japan. (It keeps the clear shape of landslide features and the action occurred at the whole of the topographic area).

**Fig.3.13** shows the over view of landslide topography. The Sabuta landslide in Yamagata Prefecture was marked as a large scale landslide topography. There are many scarps in shape of horse shoe and many small cracks in the behind. It is easy to recognize a typical landslide topography from the geomorphic point of view. But, no direct landform deformation has occurred last several decades. So there were several opinions of the risk of reoccurrence of landslide hazard. At the spring 1998, the toe part collapsed to the river and the road at the part of crown subsided gradually. The action restarted by the area of 600m in width and 1,100m in length. The velocity of the surface movement reaches to several meters par year. The surface of rapture revealed at the depth of 70m by borings. Actually a part of the area deformed and slipped down into the river about 50 years ago. 38 lives had lost at that action.

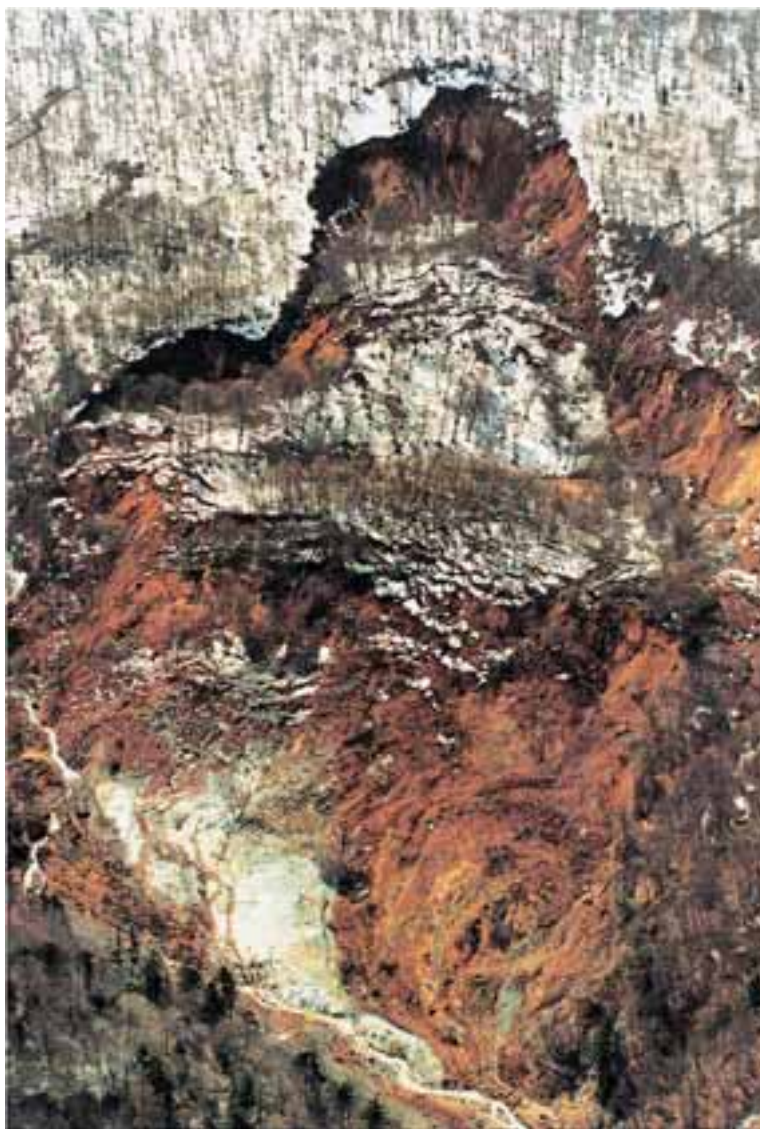
**Fig. 3.14** An overview of Sumikawa Onsen landslide and debris avalanche. The landslide occurred at a part of landslide topographic area (Half of the body remains at the area and the rest moved away as a debris avalanche to the 2km downstream).

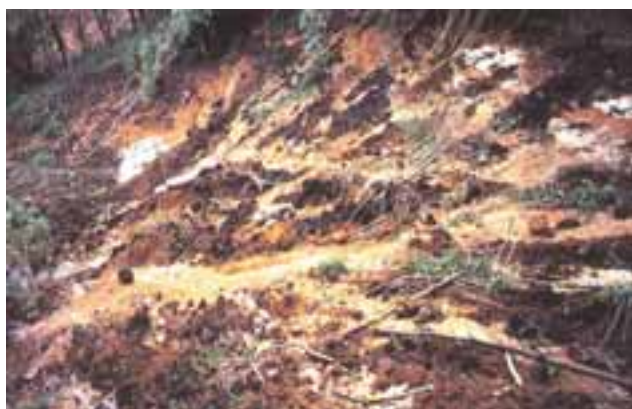
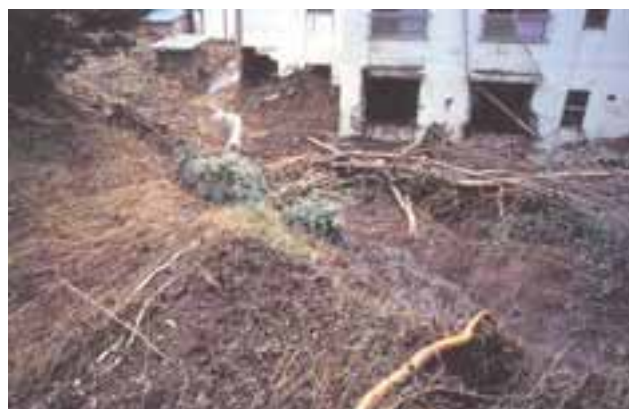
(a)

(b)

**Fig. 3.15** Rapid flow landslide hit a building Fukushima Prefecture northeast Japan. (a); The source area of landslide stripped the slip surface and the body might be moved very rapidly on the film water. (b); There is nothing of any debris and no erosion. The materials transported to several hundred meters.

Northeast Japan received a huge amount of rainfall by the combination of low pressure and typhoon during August 26~31, 1998. The total of rainfall reached to 1,250mm. The small landslide occurred near the center of rainfall (**Fig.3.15**). The landslide has distinctive characteristics. The materials slipped down the valley head and valley bottom very quickly without any deposition and dissection, the body hit a building and broke the window and the inside, then the material ran about 150 meters and diffused as a thin debris bed. The gradient of the slip and transportation surface is very low (6 degree), the volume is small (2,500 cubic m) but the destruction force is very large. We think the force comes from the velocity. Thus we call the landslide rapid flow. 5 victims were in and around the building.

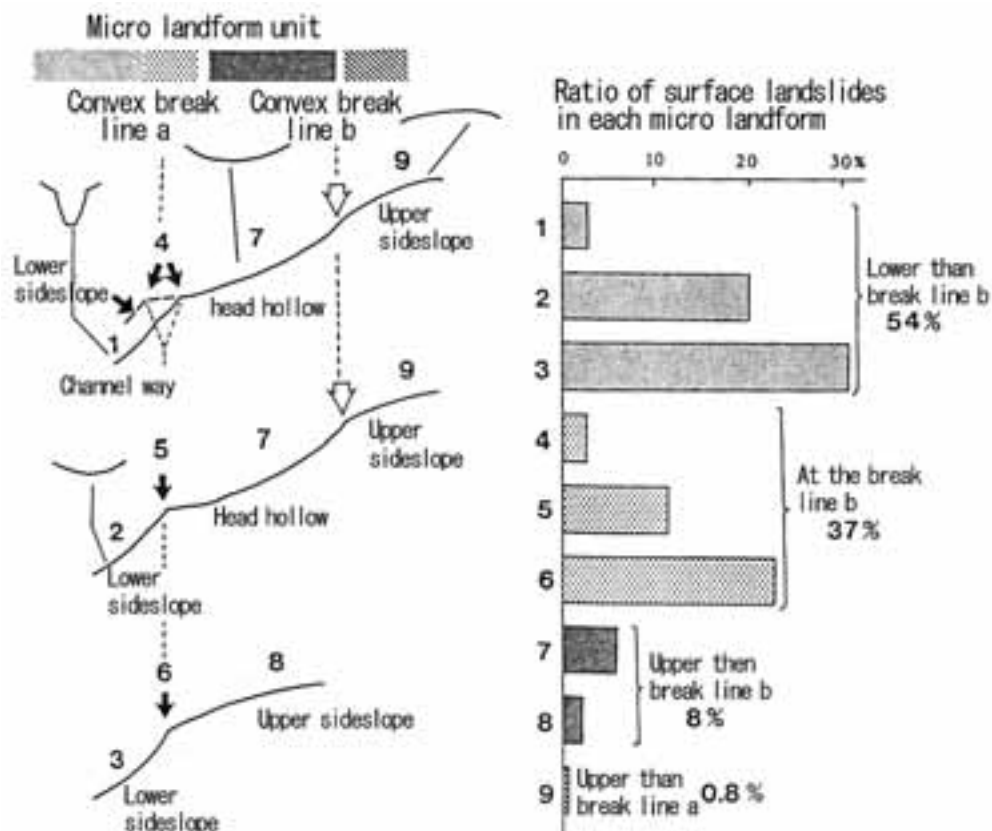
**Fig. 4.3** Ratio of surface landslides in each micro landform units.

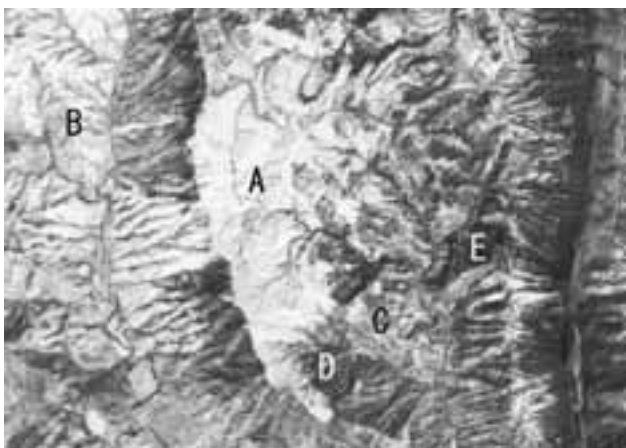
**Fig. 4.7** An aerial photograph at mountain side of Lomsak basin Pechabun province, Thailand. The area classified into five levels of land cover. A to C is degraded vegetation area especially A is completely changed to bare or grass land. Tree line can be seen just along the channels. B is the vegetation coverage is slightly higher than A. Although there are many bared stripes or patches that seems as a features of surface erosion. The land cover type A and B, the strength of grasp of soil by tree roots must be reduce and the surface runoff and infiltration getting quickly, it will lead the surface erosion and surface landslide. D and E is still keeps the forest.

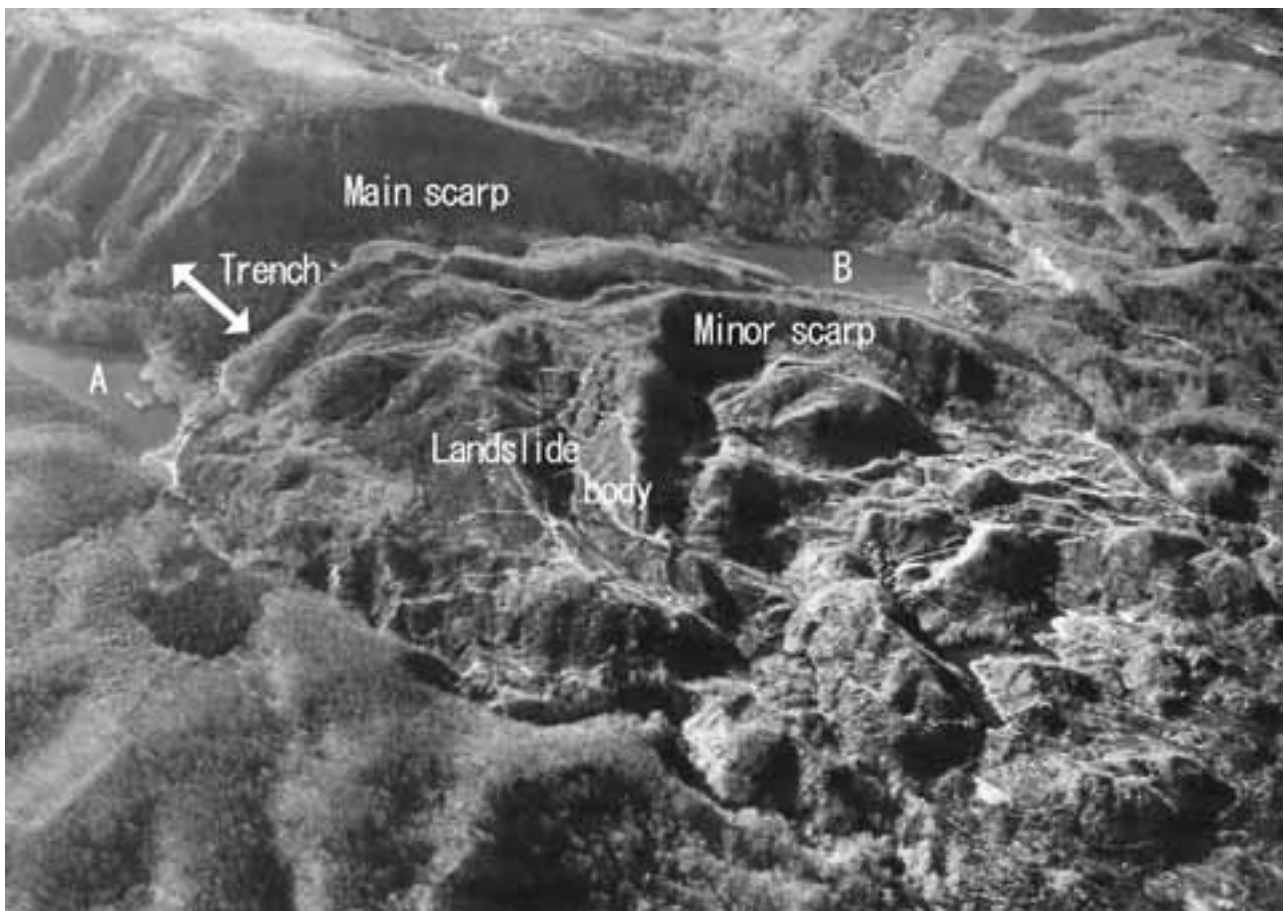
Fig. 5.5 An overview of typical "large scale landslide topography". Shironuma landslide area distribute at the foot slope of the Funagata volcano, Miyagi Prefecture northeast Japan.

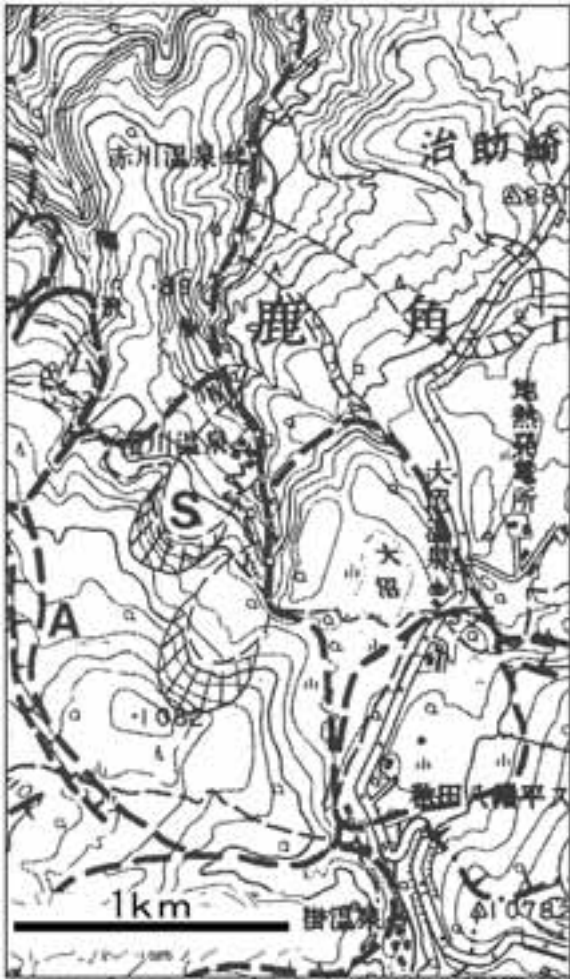
Fig. 5.12 Landslide topography map of the area in Fig. 5.12. The landslide which has mentioned in Fig. 5.12 occurred at the marked place. This is an example the ability of forecast the landslide reoccurrence (after Inokuchi, 1998).

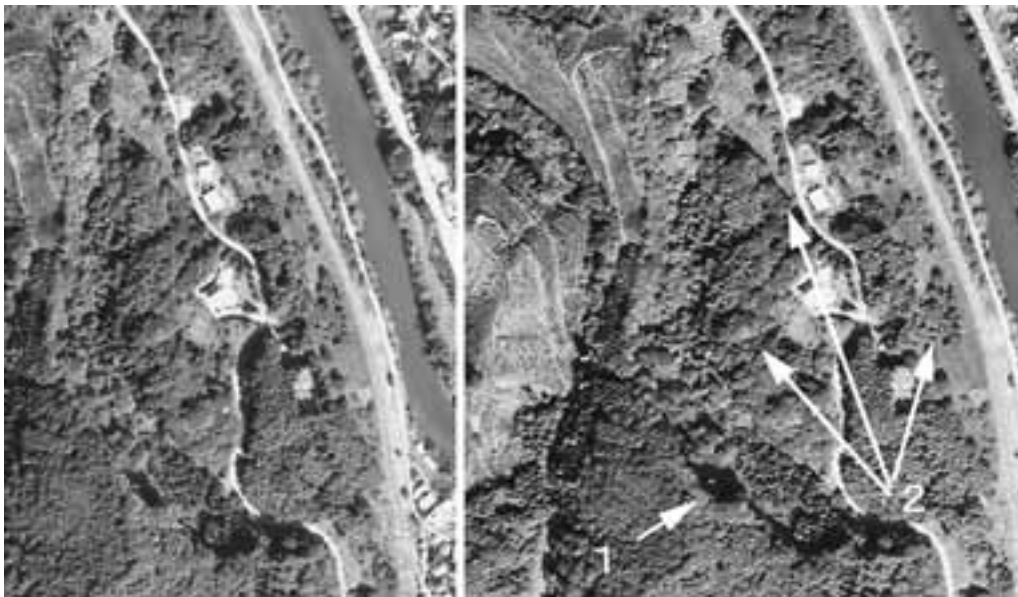
**Fig. 6.6.c** Separation scarp. Weight value: 2.0.

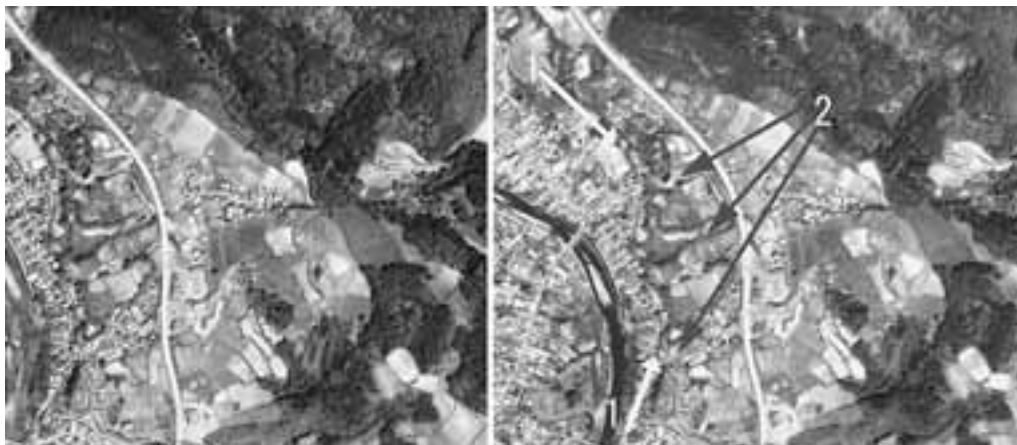
**Fig. 6.8.b** Gullies development. Weight value: 3.6.

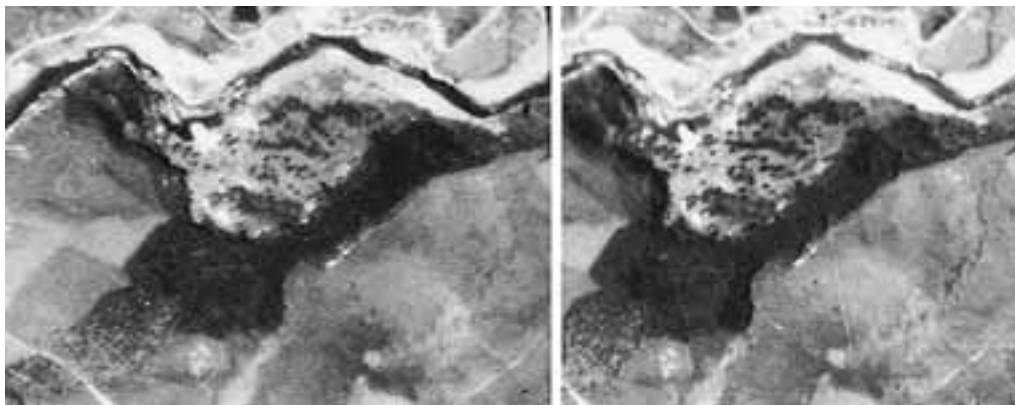
**Fig. 6.9.b** Tree crown deformation. Weight value: 6.3.

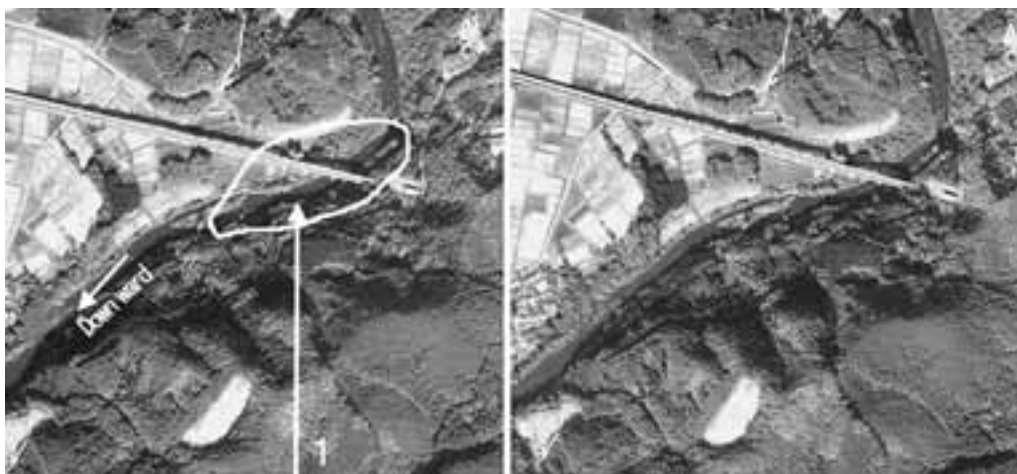
**Fig. 6.11.a** Landslide body and adjacent environment. Landslide body at lower face to the other near. Increase toward the active condition. Weight value: 8.6.

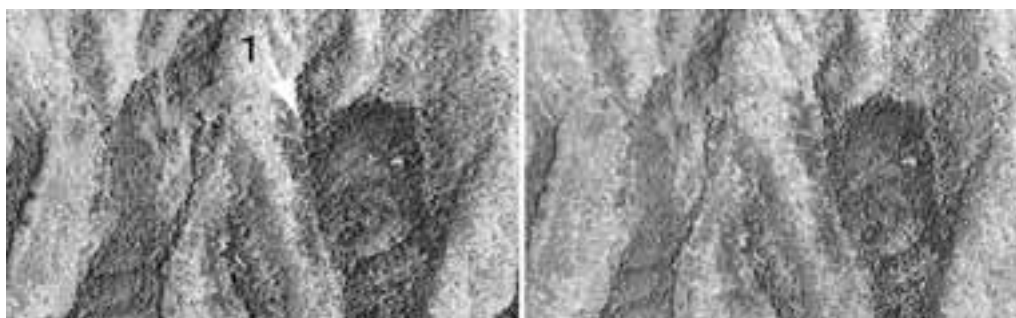
**Fig. 6.11.c** Landslide body and adjacent environment. Landslide body at lower face to the other near. Decreasing (stabilizing order). Weight value: 0.9.  
The landslide body moved but if it stop by any barrier the potential of reoccurrence should be decrease.

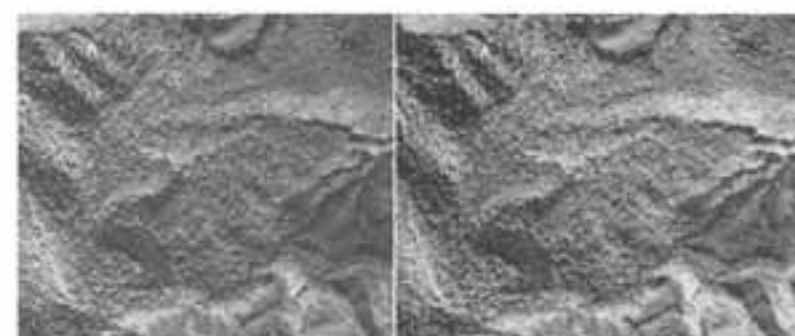
Mitsumoto-dake Mt. Score 71
