## 2015年4月ネパール地震 (Gorkha地震) における 建物被害に関する情報収集調査速報

### Flash Report on the Damage of Masonry Housing Caused by Earthquake in the case of Gorkha Earthquake, 25 April 2015

## Flash Report on the Damage of Masonry Housing Caused by Earthquake in the case of Gorkha Earthquake, 25 April 2015

Tsuneo OHSUMI\*, Hiroshi IMAI\*, and Hiroshi INOUE\*

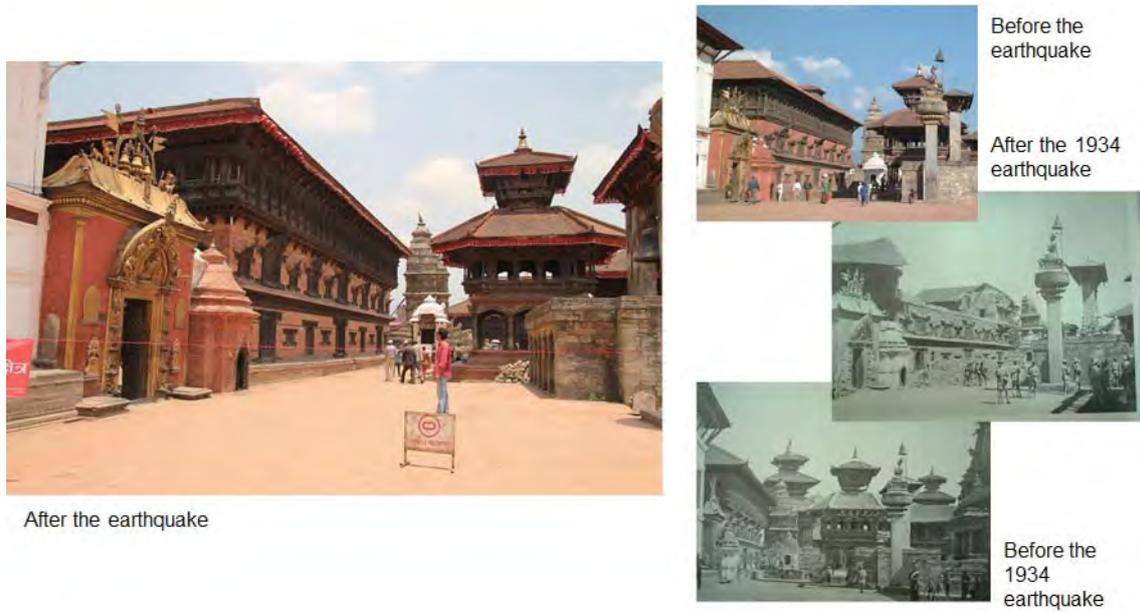
“Bhakta means” Devotee in Sanskrit, and “pur” means city. Thus, Bhaktapur is the city of devotees. Bhaktapur’s Durbar Square is a conglomeration of pagodas and Sikhara style temples grouped around a 55 Window Palace of brick and wood (**Fig. 3.1**).

**Fig. 3.1** Bhaktapur before / after the earthquake (Photo. by T. Ohsumi), before / after the 1934 earthquake (Courtesy of MoHA).

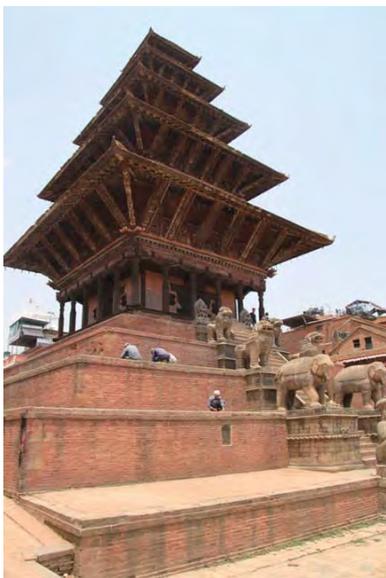
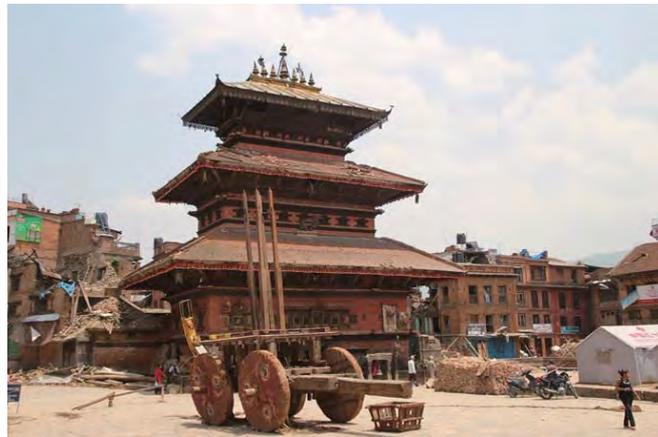
Nyatapola Temple, which is a five-storied pagoda, was built by King Bhupatindra Malla in 1702 (**Fig. 3.6**). This is one of the tallest pagoda-style temples in Kathmandu Valley and is famous for its massive structure and subtle workmanship. This temple survived in an earthquake in 1934. This temple remained with a minimum of damage, the reliability of the building technology is being evaluated. The Bhairavnath temple was destroyed by an earthquake in 1934 and subsequently rebuilt.

**Fig. 3.6** Nyatapola temple (left) and Bhairavnath temple (right) are no damage (Photo. by T. Ohsumi).

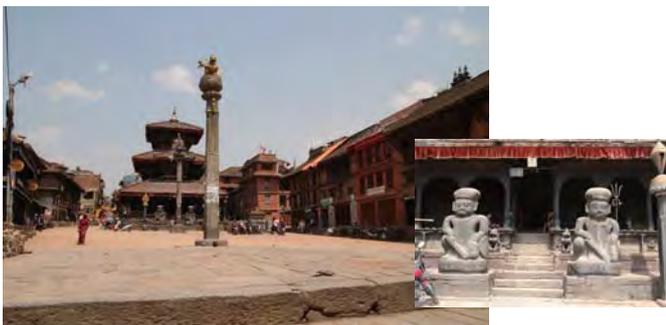
The God Bishnu festival is held in the Dattatraya Temple (**Fig. 3.7**). Usually, this festival is organized every year from July to August. In front of this temple, two statues watchmen/guardians are standing, who provide against evil and disasters. Two watchmen hold Grakata, which is the preferred weapon of Lancers.

**Fig. 3.7** Main Dattatreya temple at Dattatreya Square (left), two watchmen / guardians hold Grakata (right) (Photo. by T. Ohsumi).

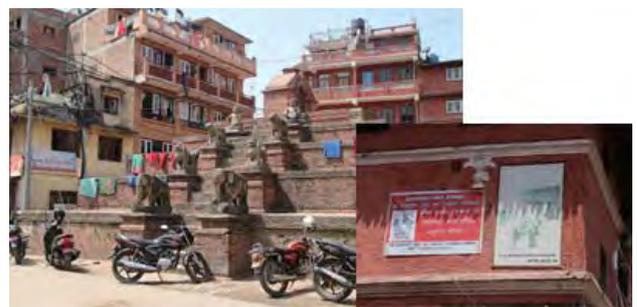
The Nepal calendar is currently 2072. Thus, Nepal 1990 B.S. (Bikram Sambat) correspond to 1934A.D. State, this temple collapsed but has not been rebuilt (**Fig. 3.8**). If such non-reconstruction of historical buildings that have been lost during earthquakes does not proceed, it will be a major blow to the future Nepal’s tourism-oriented country.

**Fig. 3.8** This temple collapsed in 1934 earthquake, but has not been rebuilt (Photo. by T. Ohsumi).

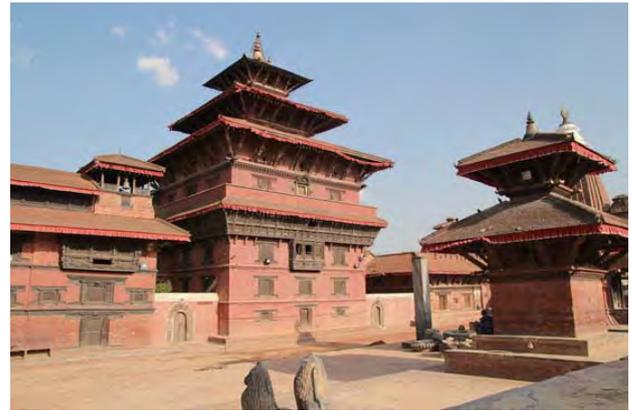
Thus, in Patan, 2015, after the earthquake, this place had only partial damage at Gajur and Baymvah (Fig. 3.9-10).

**Fig. 3.10** Taleju three-tiered temple Lalitpur (Photo. by T. Ohsumi).

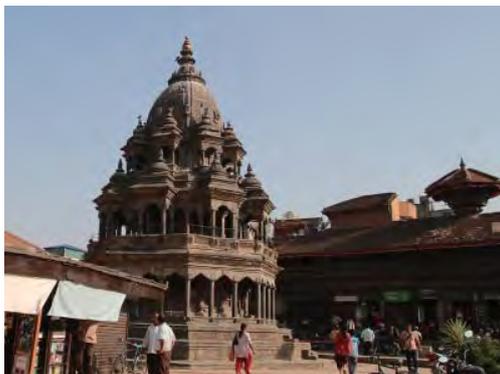
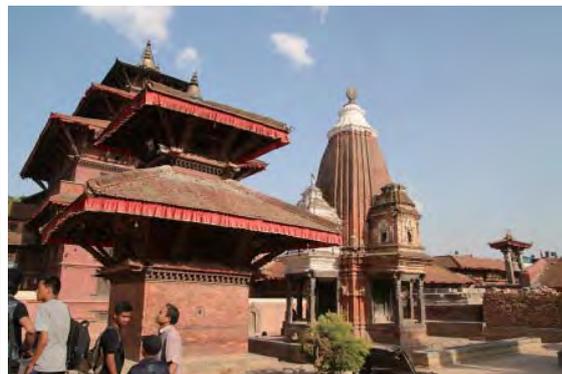
Krishna Sikhara survived. Jagannarayan Temple (left), Vishnu Temple(ceter) and Narasimha Sikhara from 1598 (front) were survived (Fig. 3.11).

**Fig. 3.11** Jagannarayan Temple (left), Vishnu Temple (ceter) and Narasimha Sikhara survived (Photo. by T. Ohsumi).

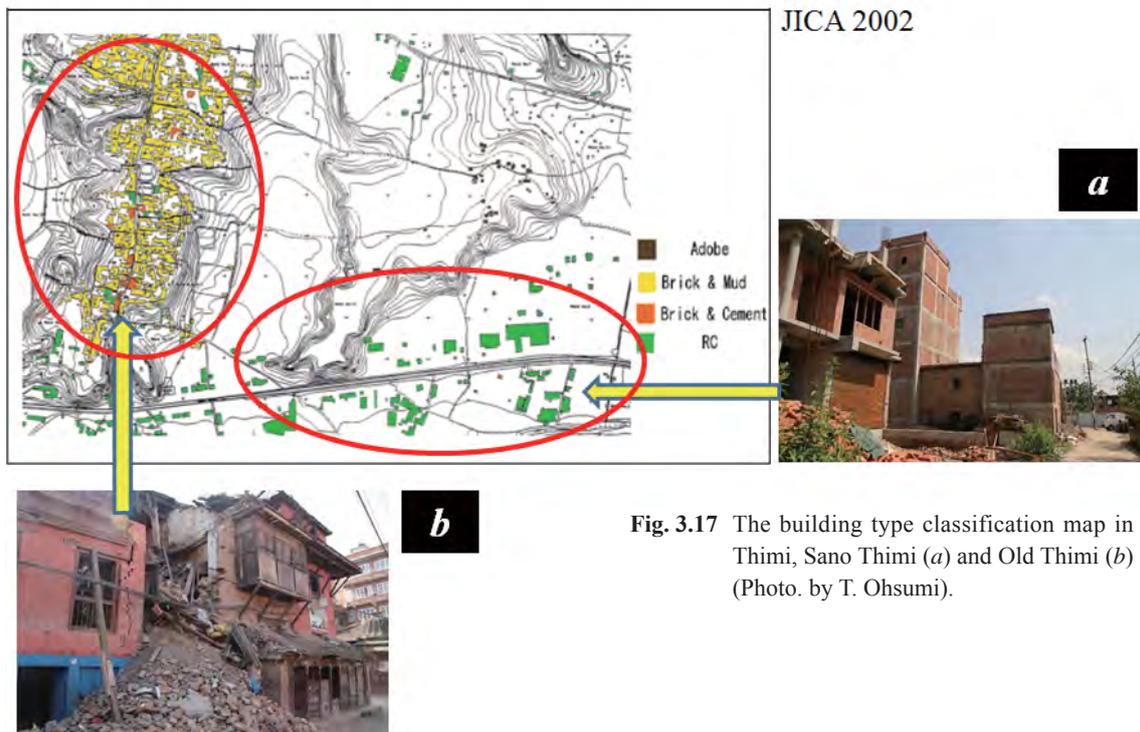
The building type classification map defined each rate of structure as 500 m×500 m mesh (Fig. 3.17: upper). In Sano Thimi (Fig. 3.17: a), with newer buildings, the damage has been reduced. Old Thimi located on a small hill (Fig. 3.17: b), the houses were destroyed in 1934 rebuilt and again received severe damages.

Fig. 3.17 The building type classification map in Thimi, Sano Thimi (a) and Old Thimi (b) (Photo. by T. Ohsumi).

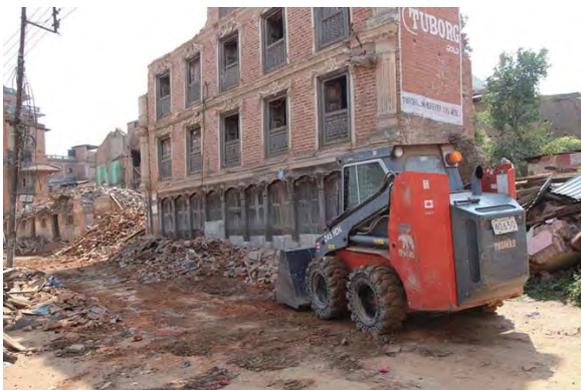
The houses damaged by the earthquake have been demolished with the support of the Canadian Forces in Sankhu. Heavy equipment was brought from Canada (Fig. 3.18). RC buildings were partially damaged the difference appears remarkable (Fig. 3.19). Damage in Sankhu was enormous, the brick and cement mortar houses without RC columns had a lot of damage. Structures having no RC columns on the corner, a vertical crack in a brick masonry wall was generated. Outer wall structures of buildings is baked brick with cement mortar joints to withstand rain. Inside wall of buildings is adobe bricks with mud mortar (Fig. 3.20).

Fig. 3.18 In Sankhu, heavy equipment from Canada (Photo. by T. Ohsumi).
